**Re: GE-Pittsfield/Housatonic River Site  
Silver Lake Area (GECD600)  
2018 Annual Monitoring Report**

# 2018 ANNUAL MONITORING REPORT

Silver Lake Area

February 2019

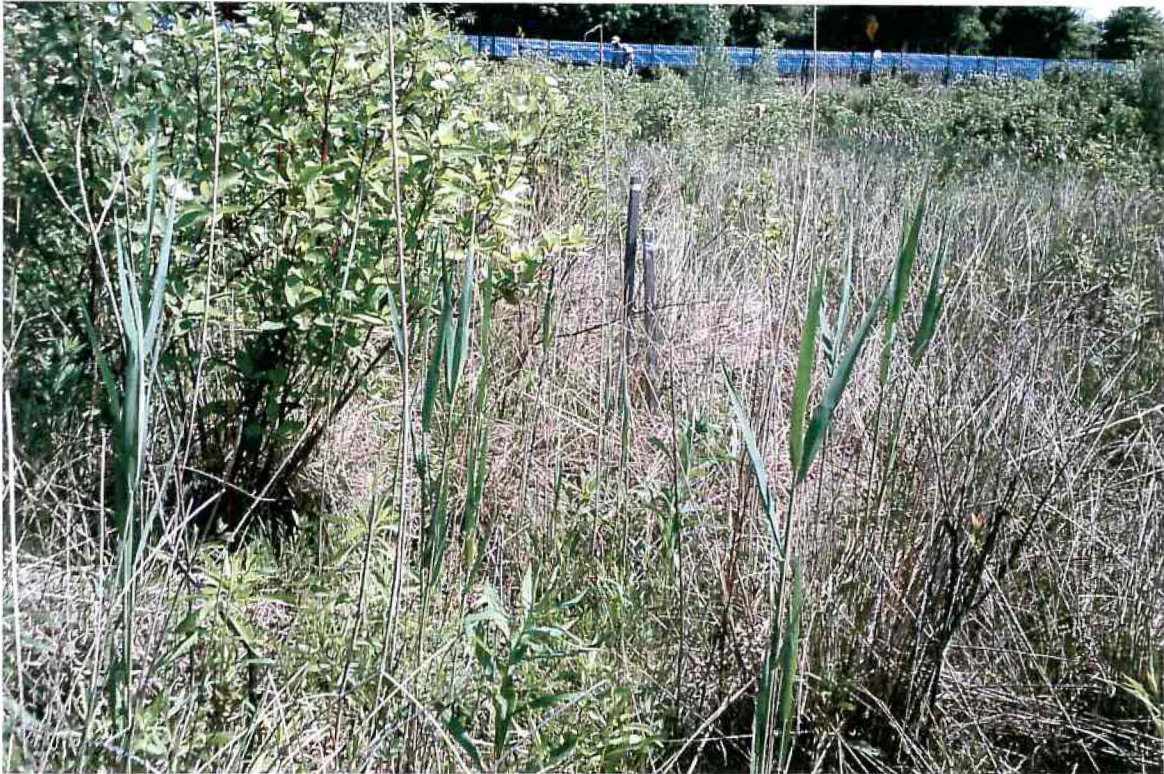
Active Viburnum Leaf Beetle larva activity.

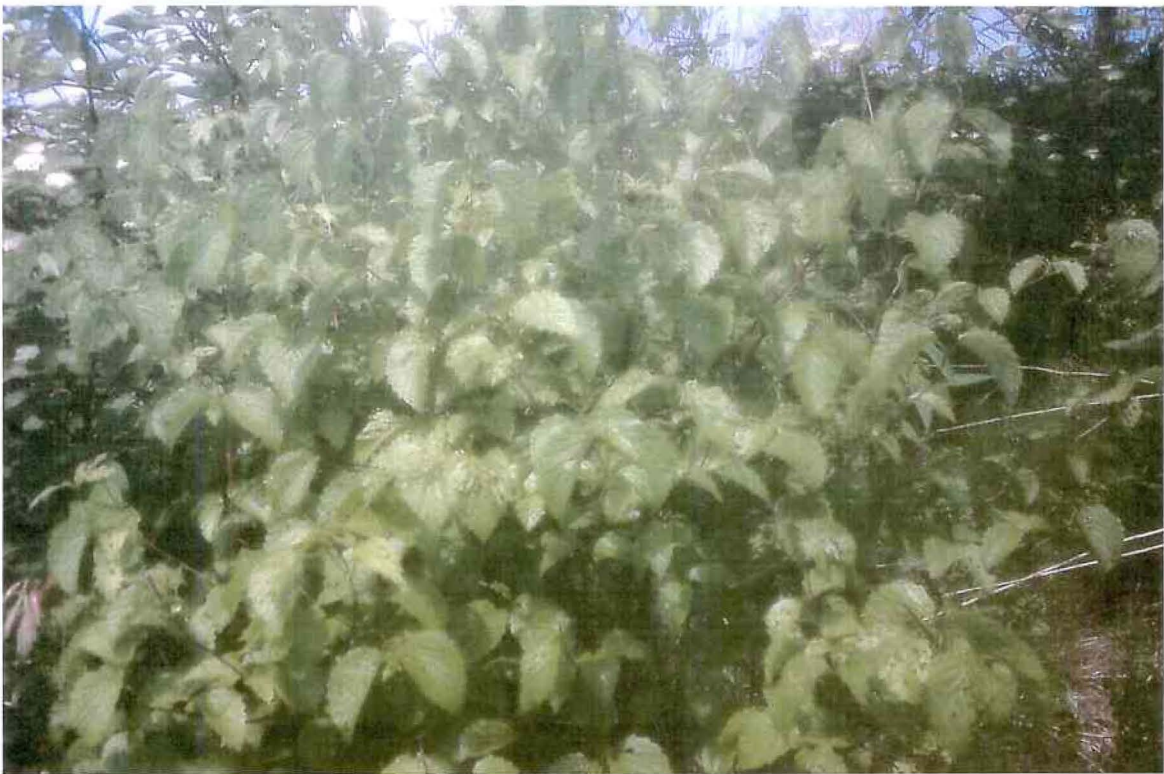
Japanese Knotweed Patch near I9-9-36

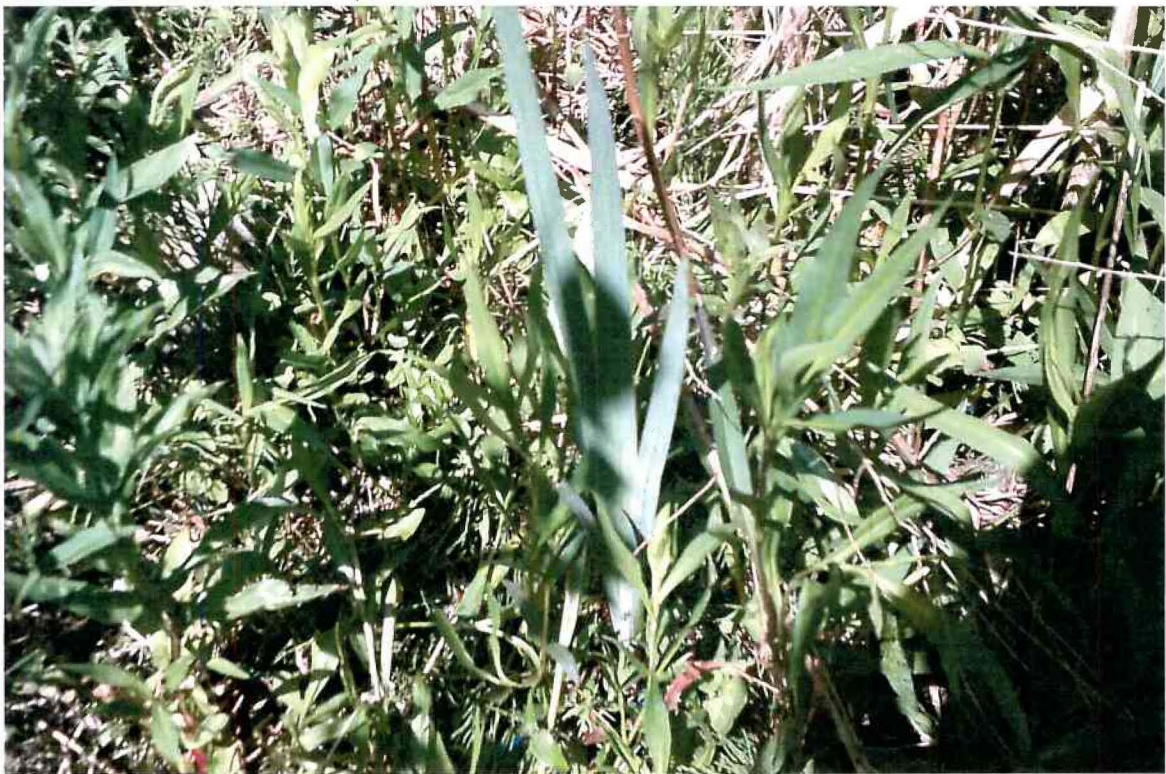
Yellow Iris Removed

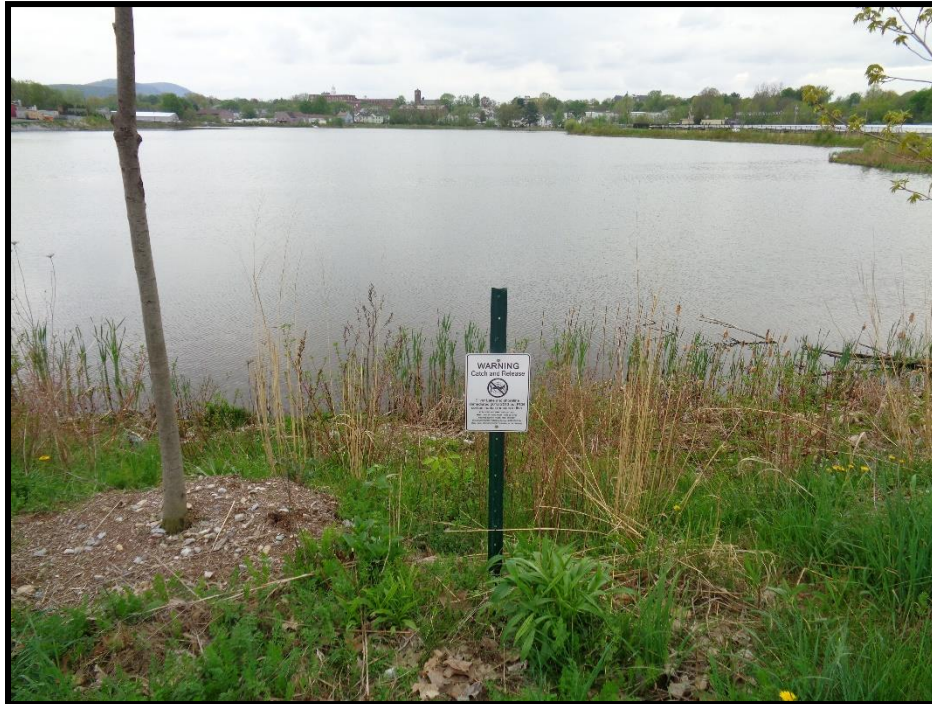
**Photograph 1: Catch-and-release sign on west side of Silver Lake.**

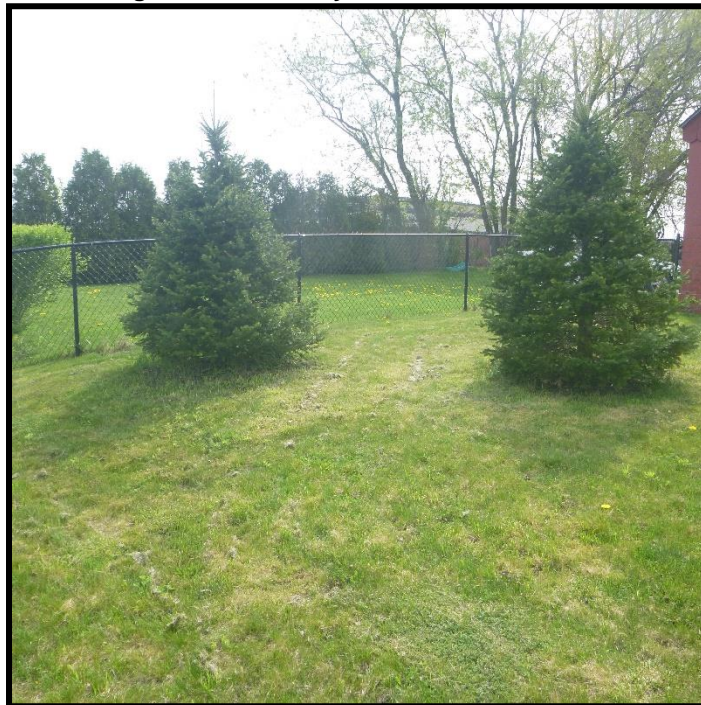
**Photograph 2: Fraser firs trees looking alive and healthy on Parcel I9-9-28.**

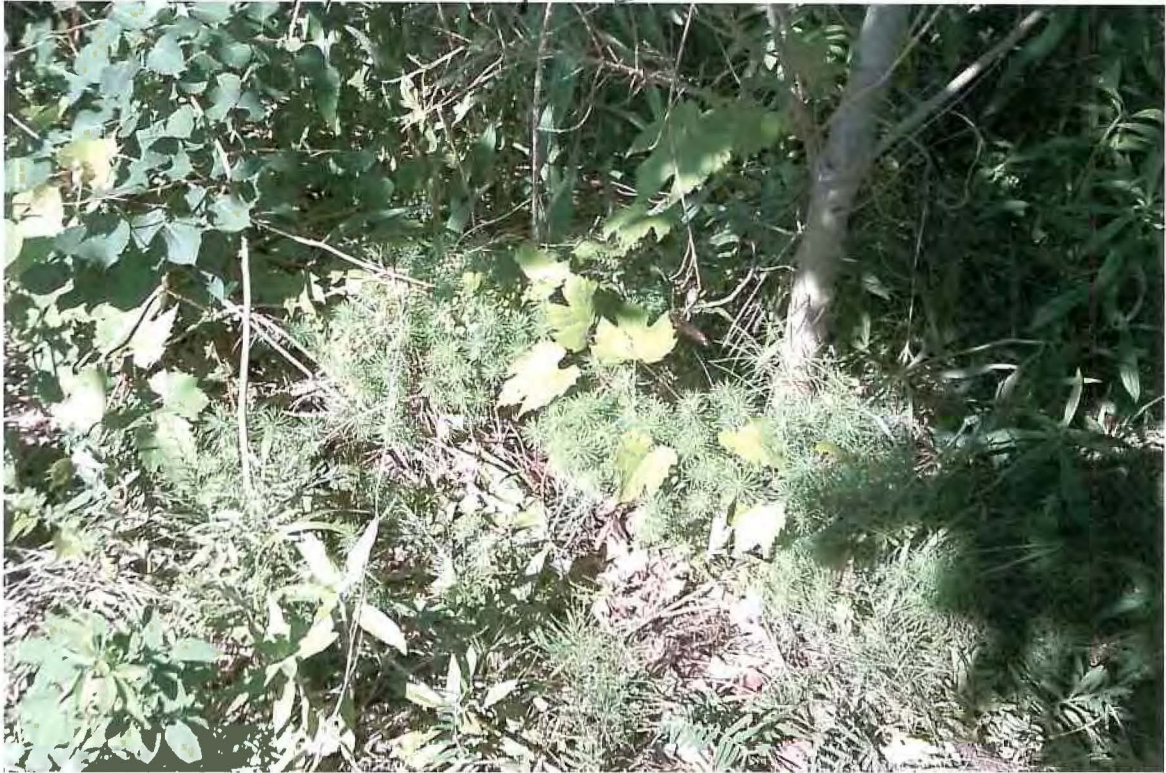
Cypress Spurge

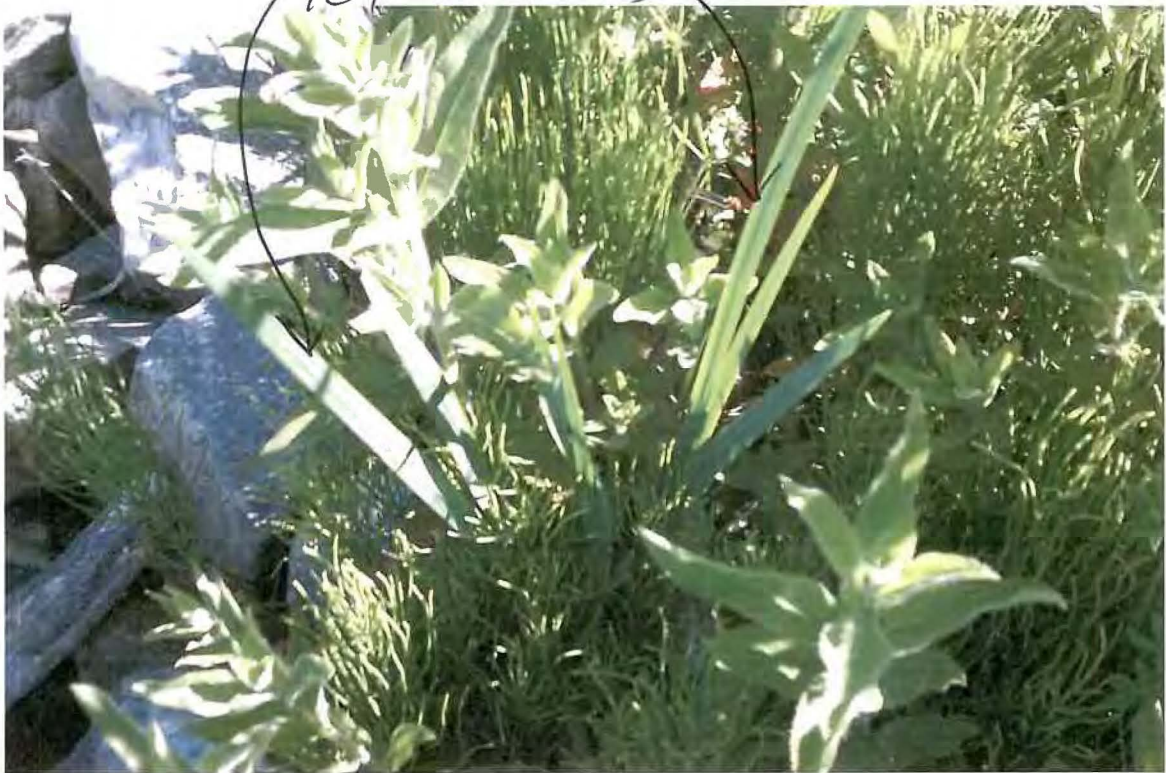
Yellow Iris

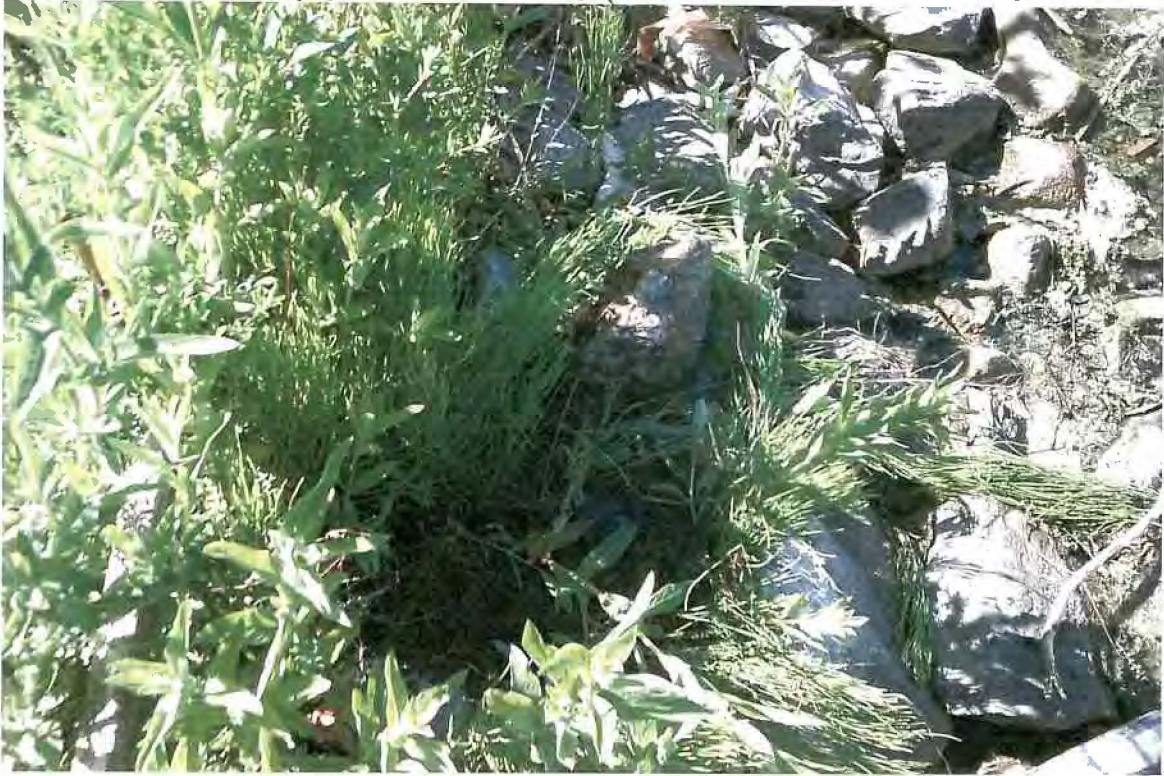
Yellow Iris REMOVED!!!

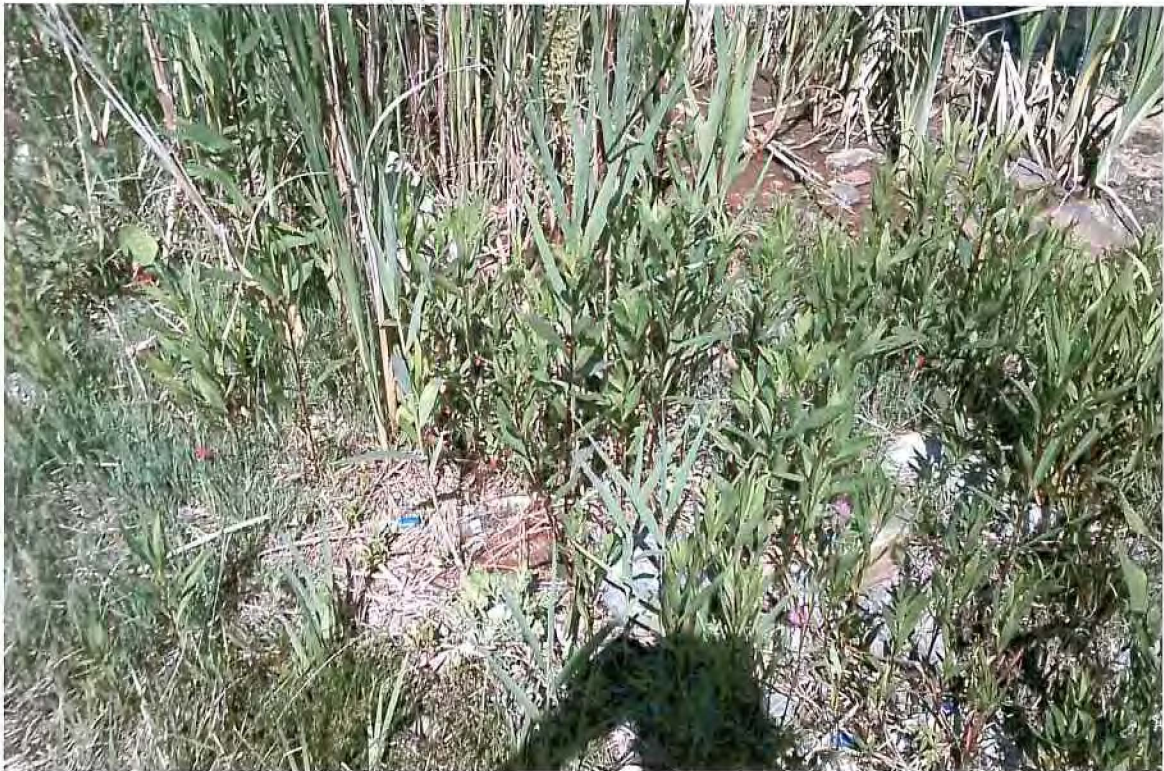
PHRAGMITES

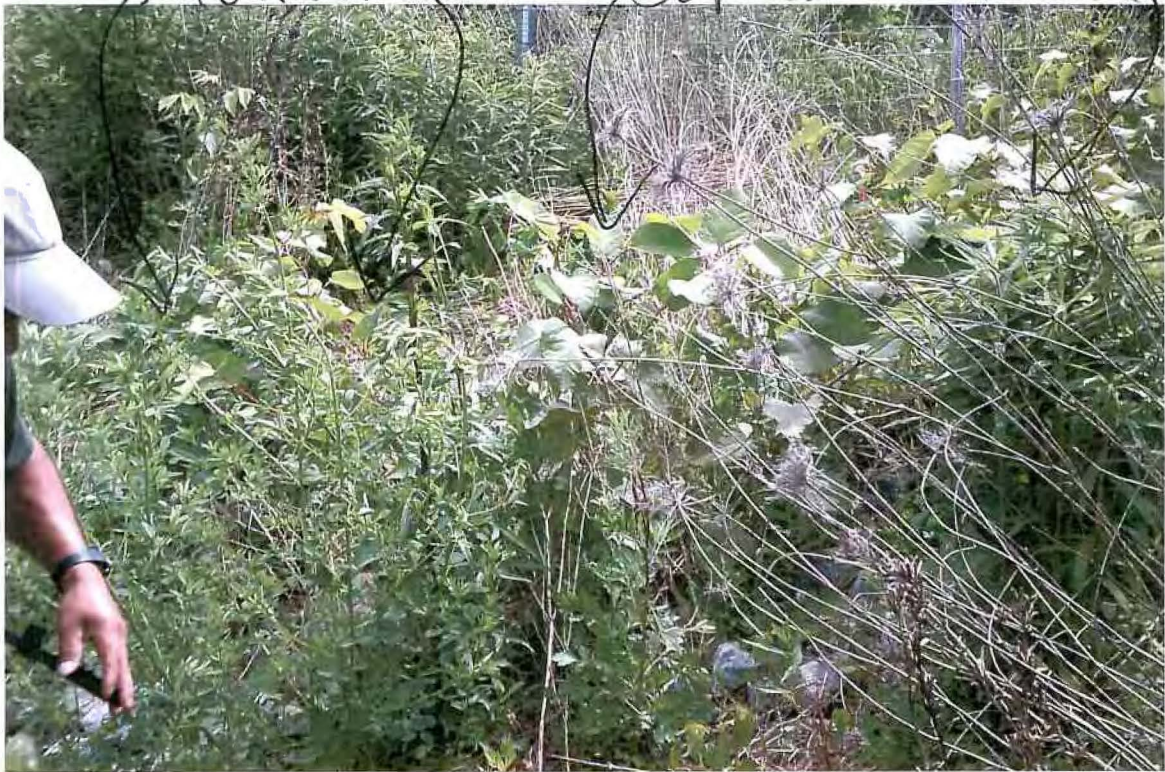
MUGWORT

Japanese Knotweed

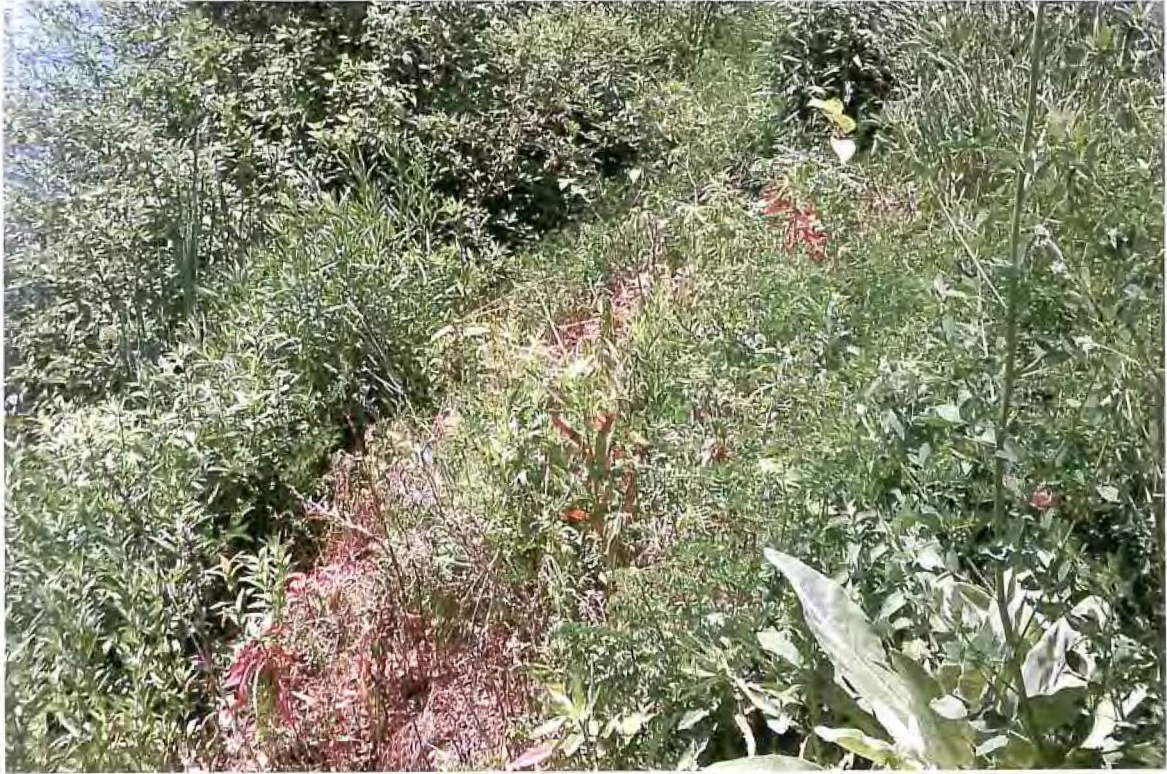
Japanese Knotweed Patch treated last  
Apr.

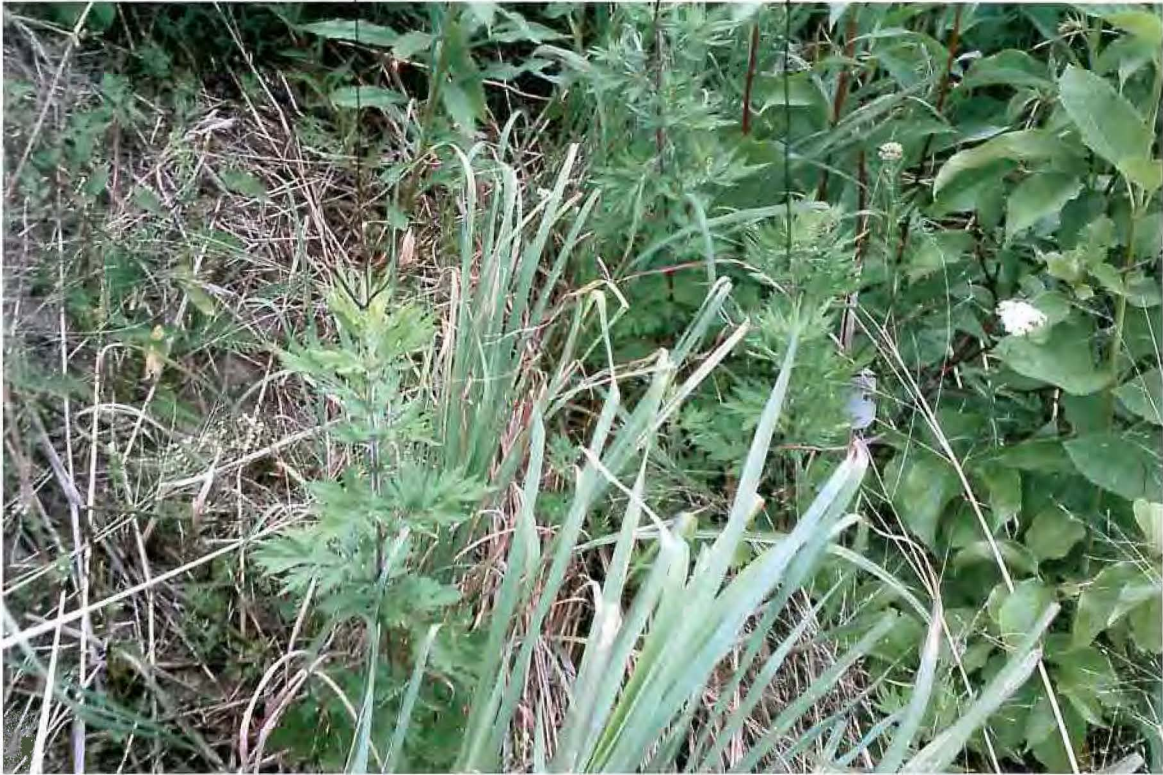
MUGWORT SEEDLINGS

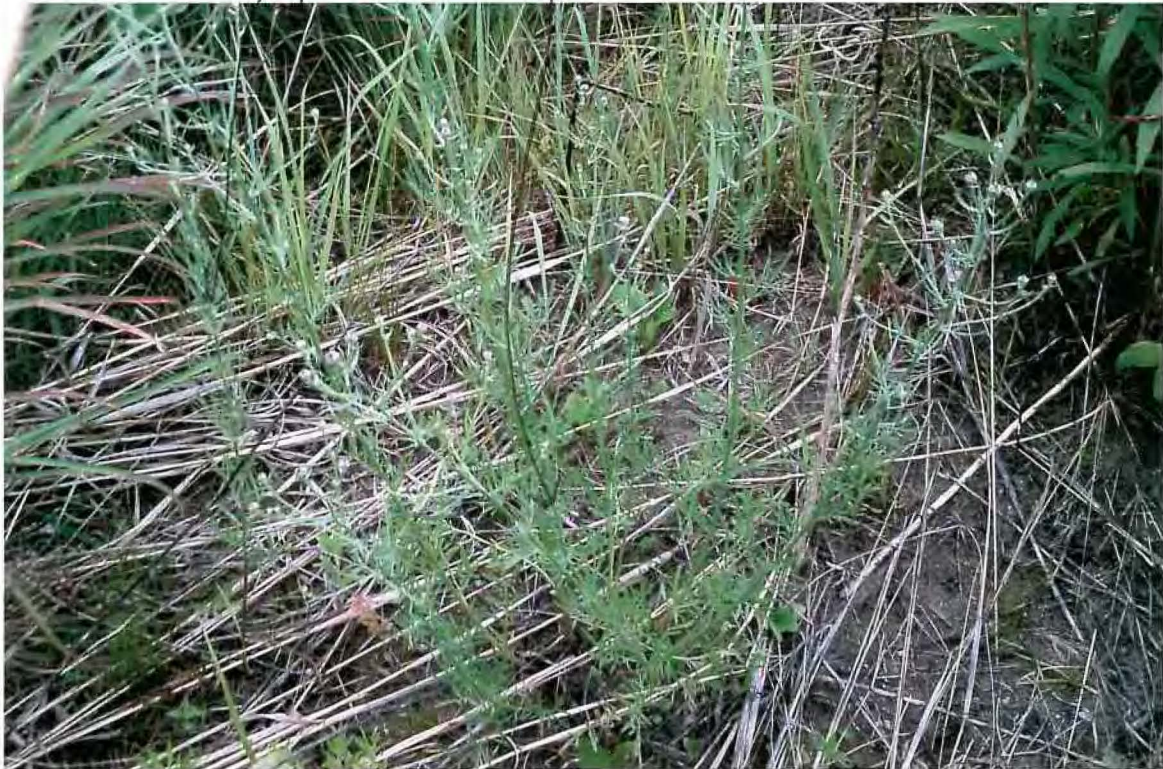
Spotted Knapweed Seedlings

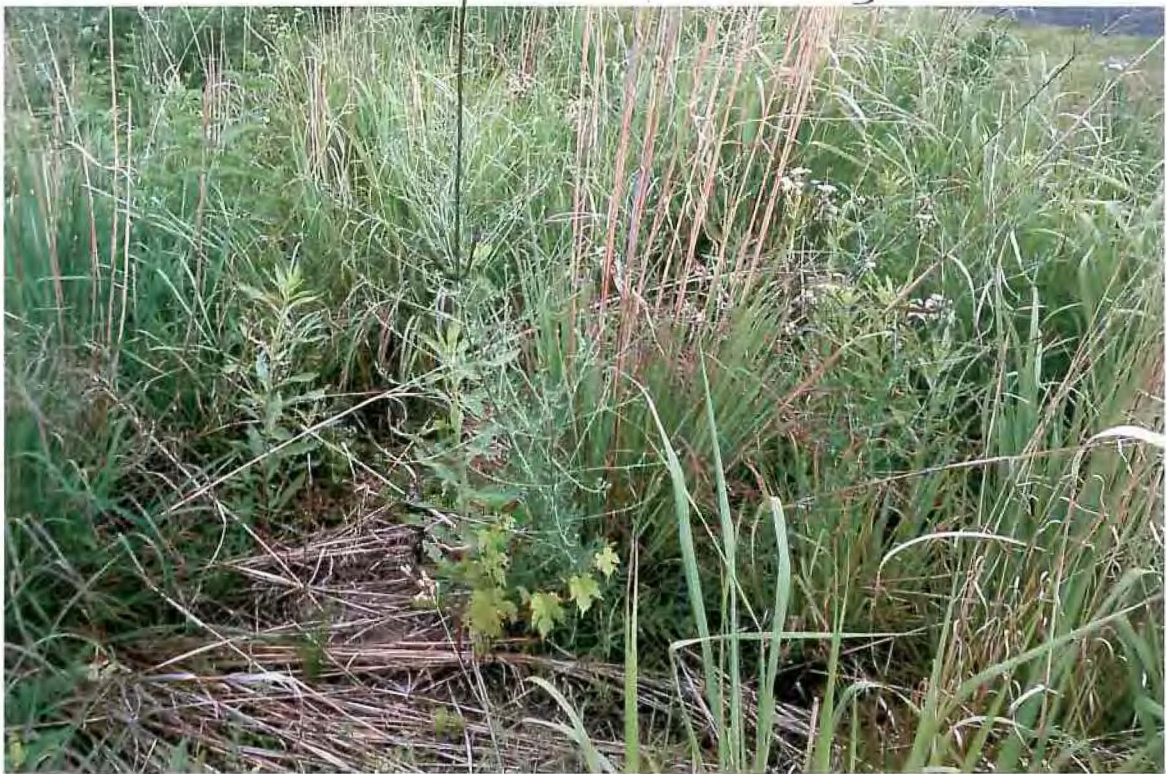
Spotted Knapweed Seedling

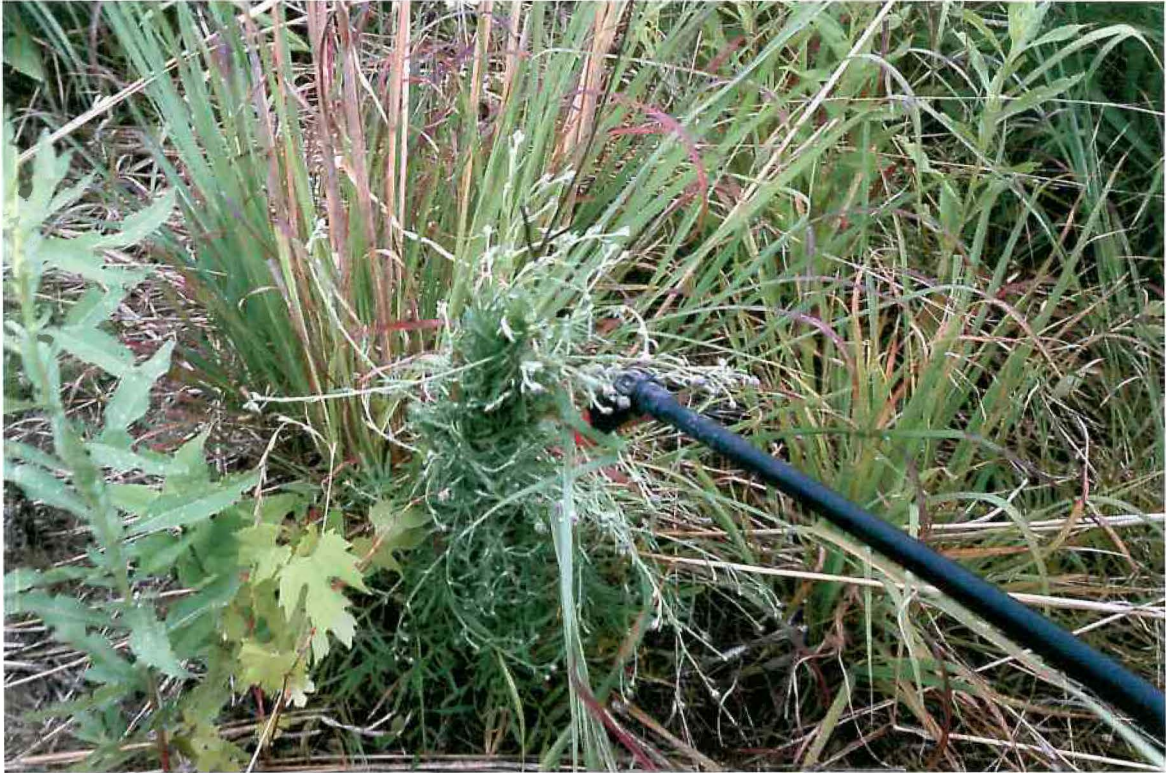
Knapweed "KNOT"

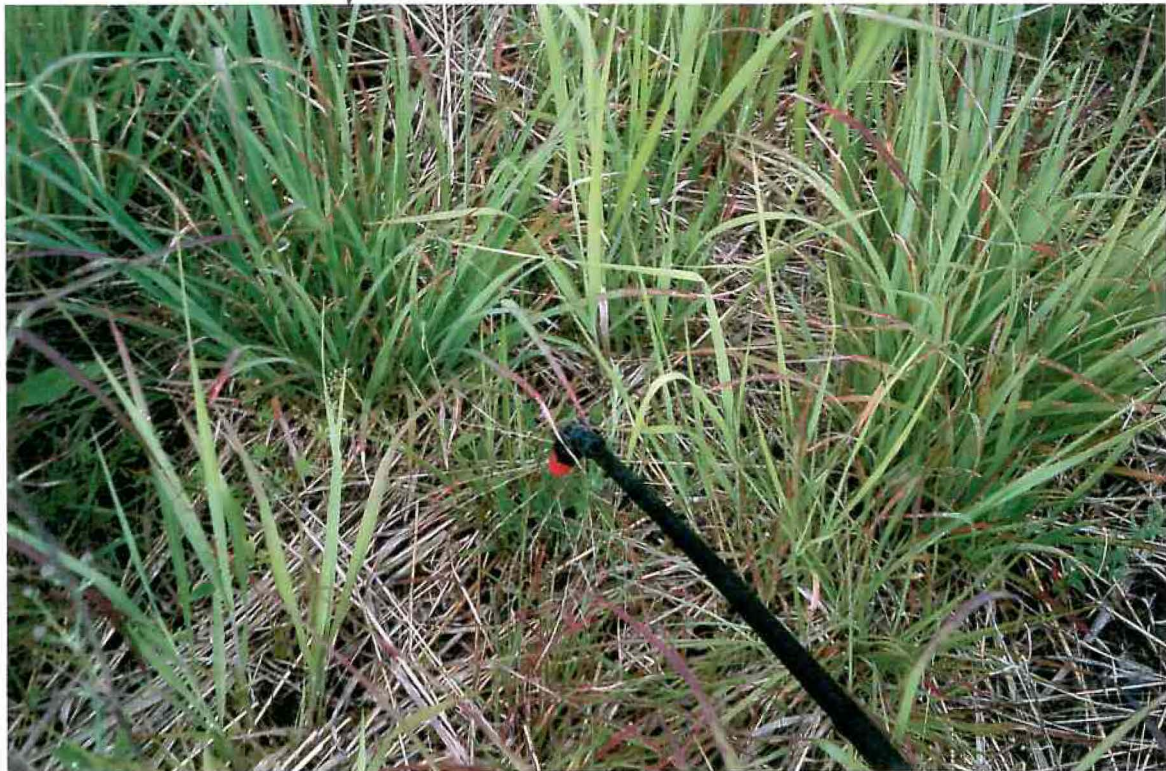
Knapweed Seedling

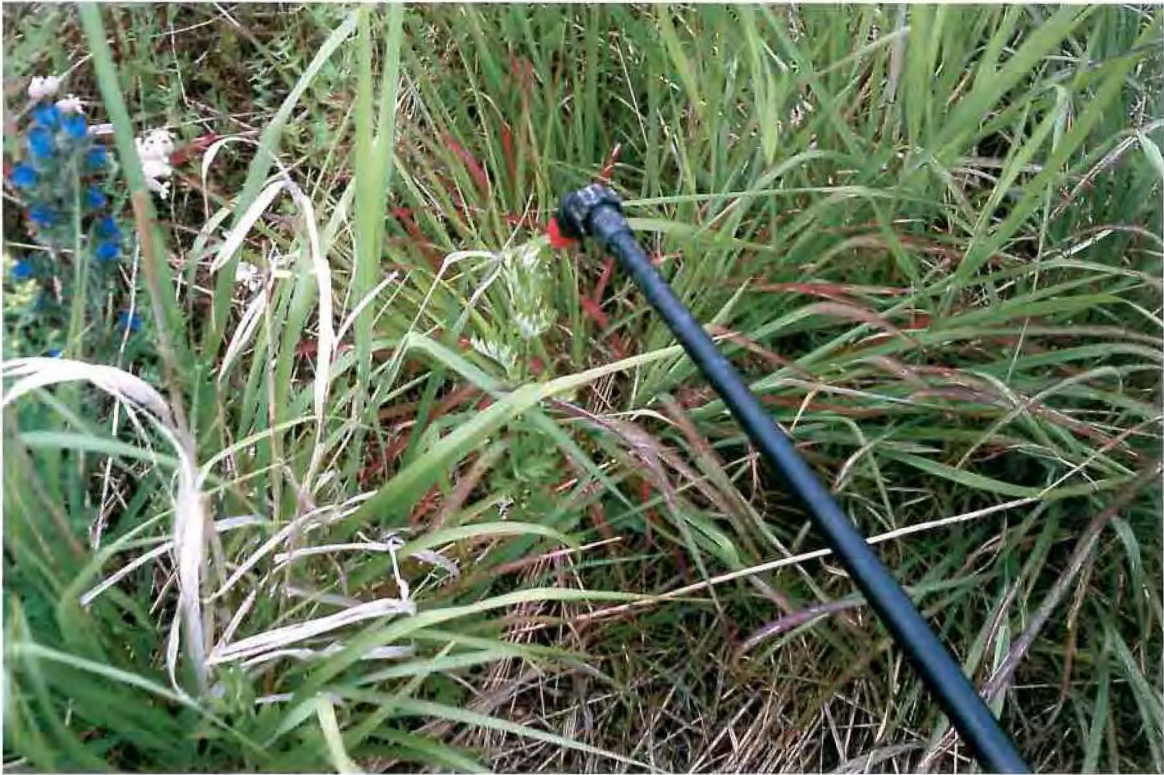
Mugwort seedling

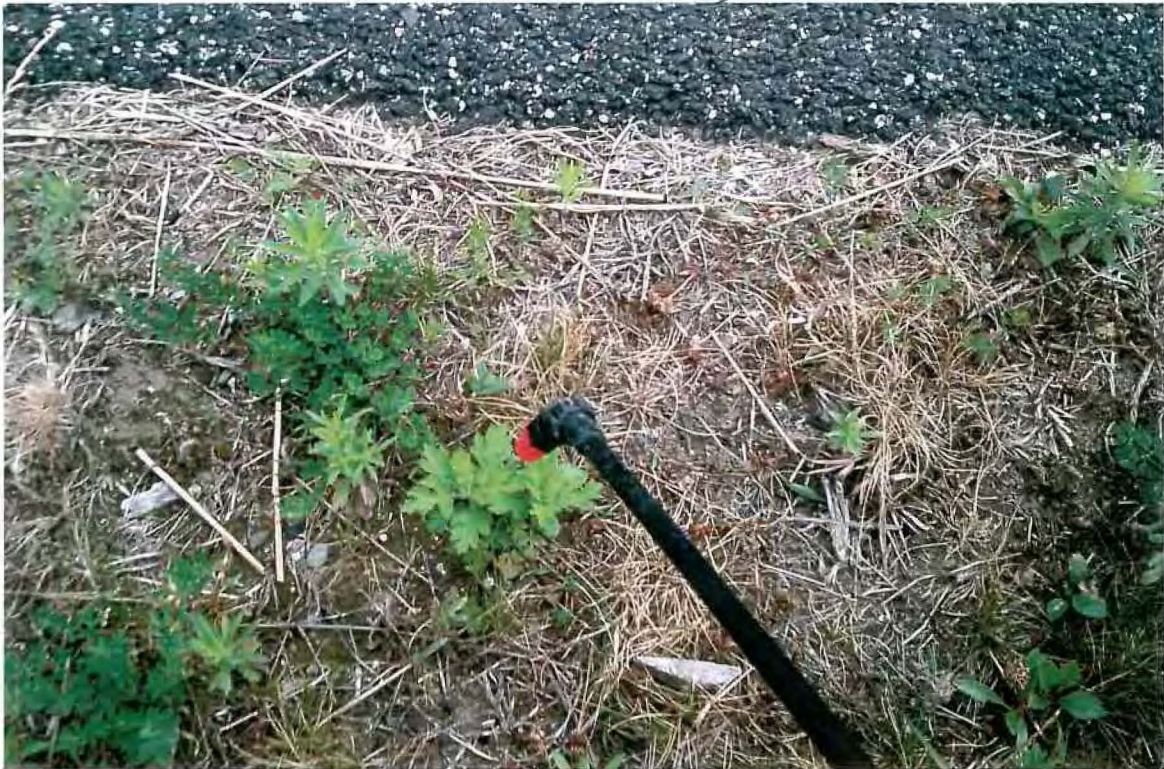
MUGWORT seedling

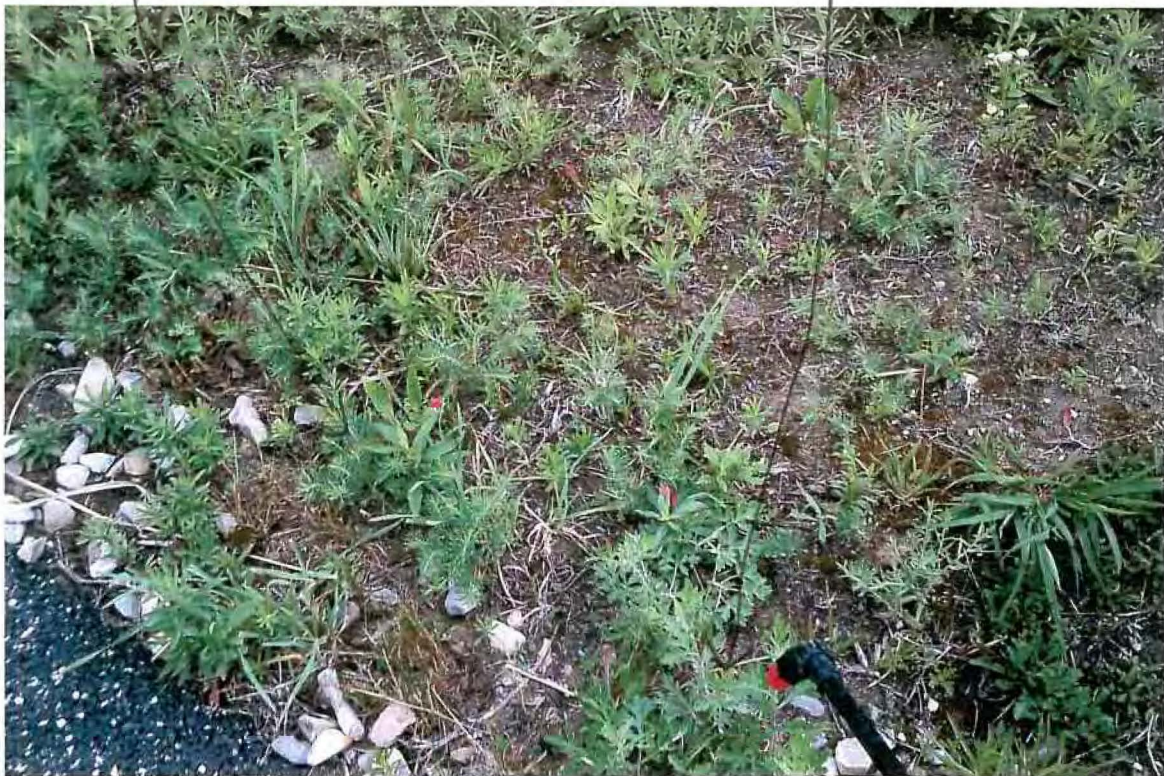
Cypress Spurge  
~~Colt's Foot~~      Close by  
Knapweed      Mugwort

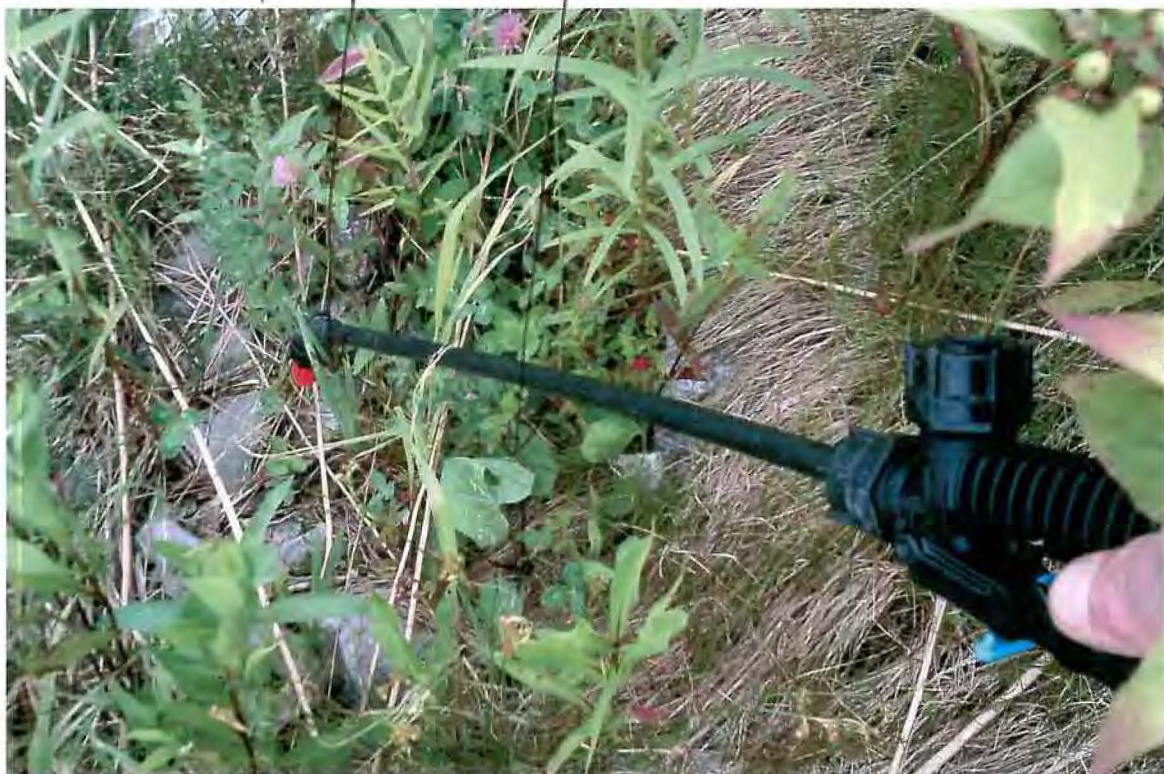
Yellow Iris      Colt's Foot

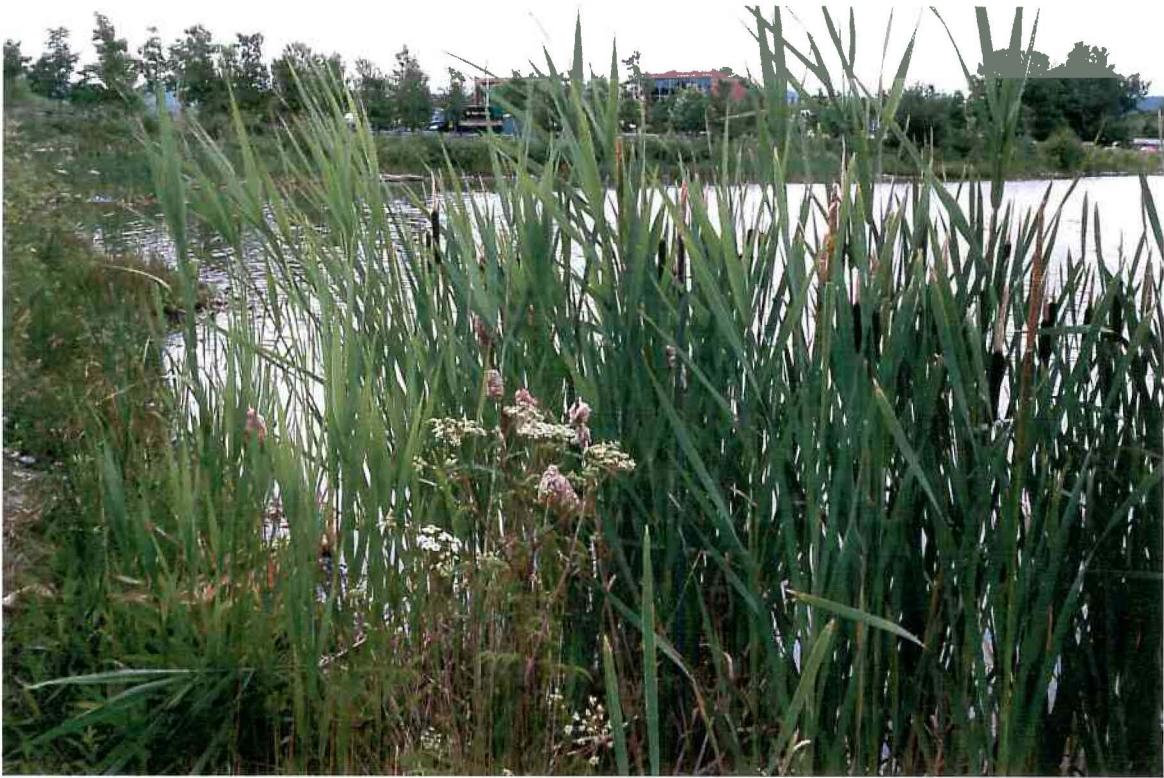
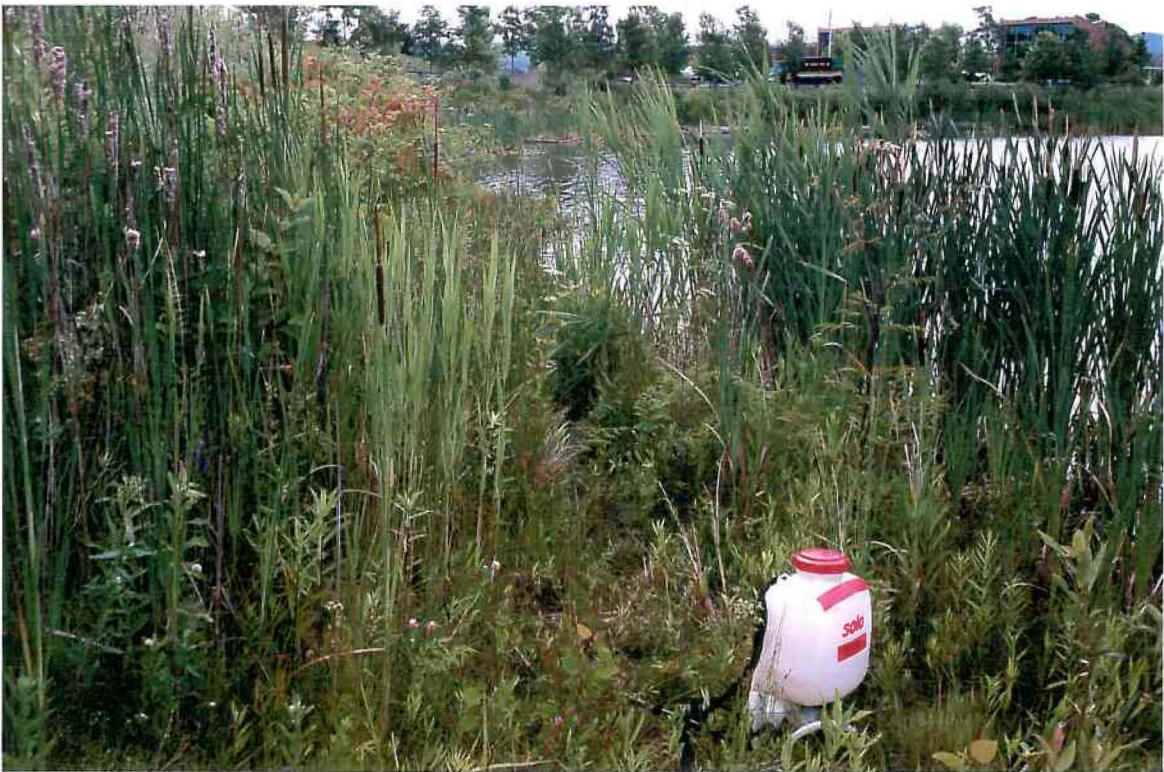
# PHRAGMITES

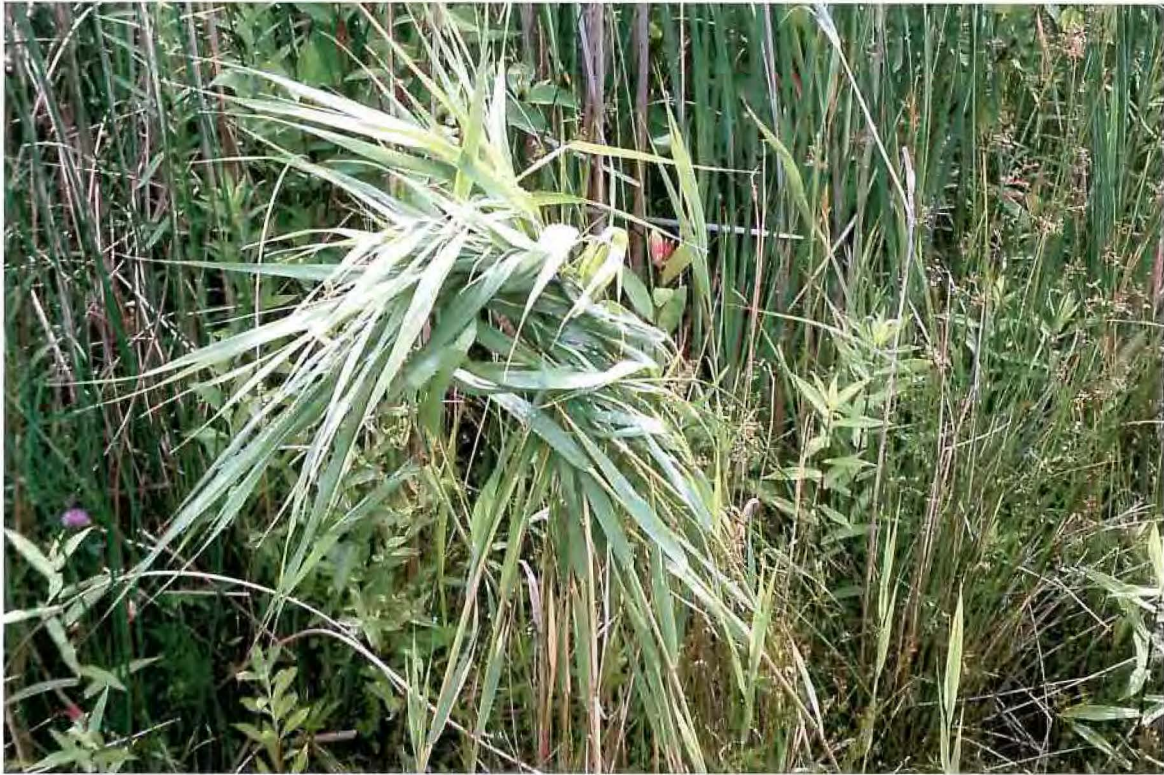
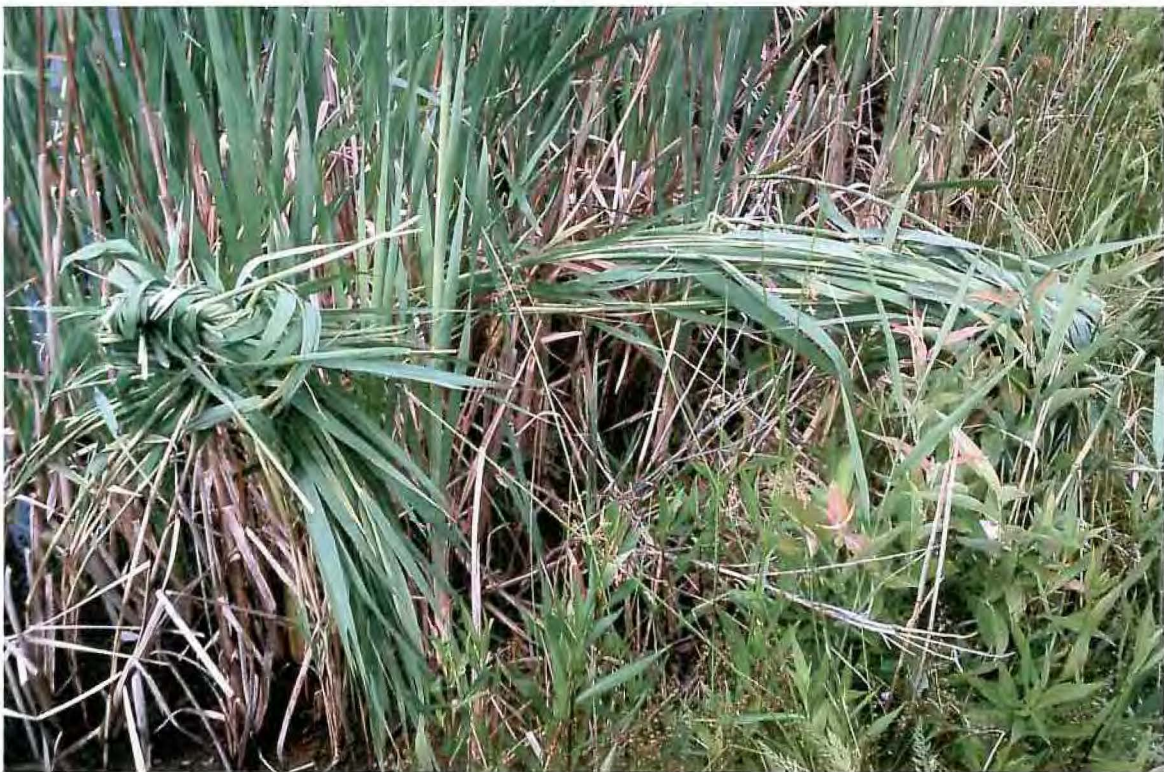
PHRAG "KNOTS"

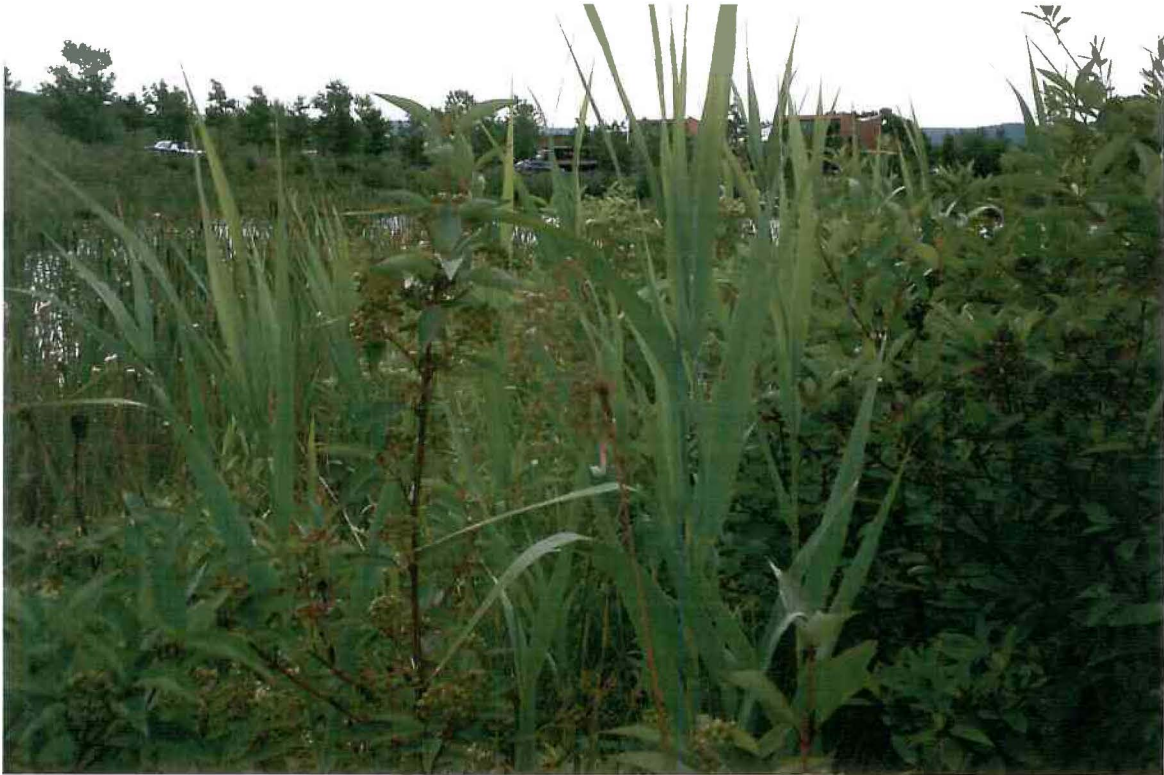
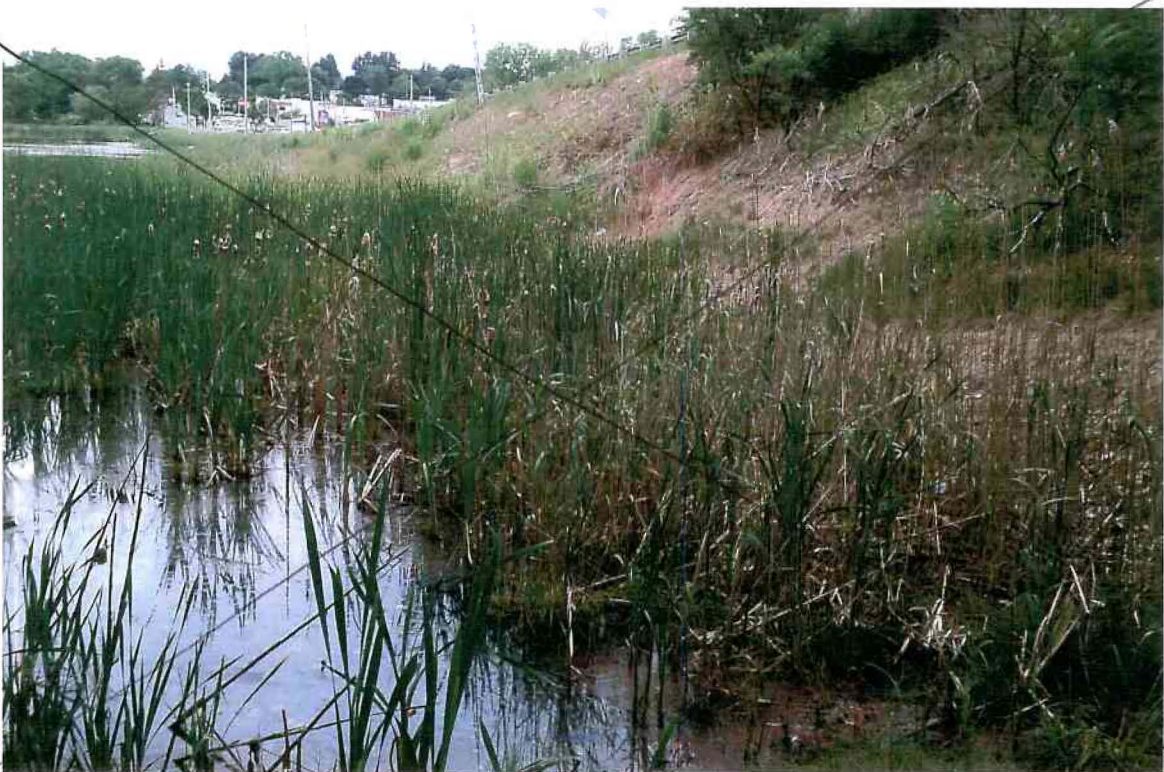
PHRAGMITES on SSI
